**Flood Control Project Maintenance
Levee Inspections**
LMA District Cover Sheet
Spring 2019 Levee Inspection Results

Reclamation District No. 0765 Glide

Levee Inspection Report By Mile - Spring 2019

Waterway	Bank	Unit Miles	Inspection Start/End	Inspector
Unit No. 01 Sacramento River	Right	1.72	04/10/2019 04/10/2019	Luz Dial

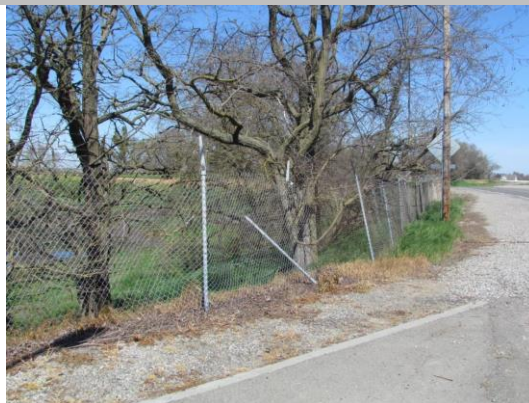
Photo 1 of 3 : SP_2019_RD0765_211_3_20190307_00003.jpg

Looking north at untrimmed trees along landward slope. (Spring 2017)

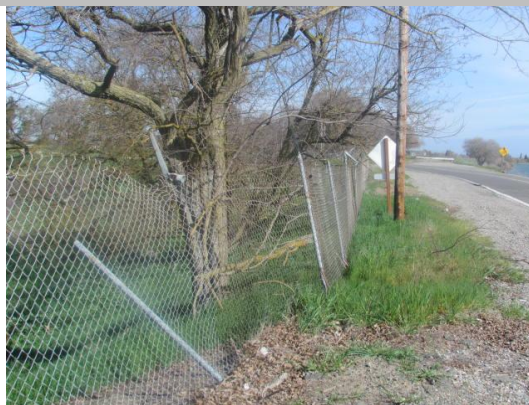
Photo 3 of 3 : SP_2019_RD0765_211_3_20190307_00005.jpg

Looking north (upstream) at trees on landside slope. (Spring 2016)

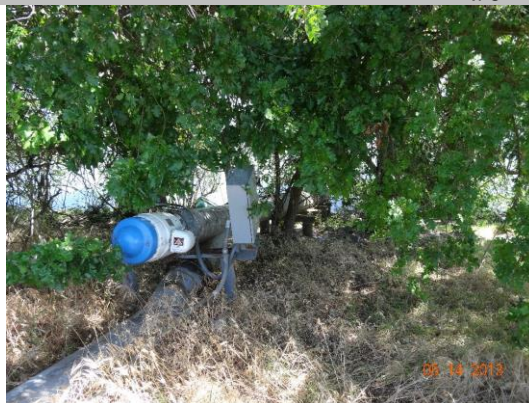
Photo 1 of 3 : UCIP_SP_2019_44403_60815.jpg

Comment Code					
Inspector Comment					
FS_ID:44403 DS_ID:21138 EP_NO: 3314 Repair Type: Non-Urgent Crossing Status: Found UCIP Comments: Dense vegetation limit's the ability to determine condition of landward slope for potential leaks associated with crossing. Recommend having owner clear slope to be able to properly inspect slopes for leaks. FIELD_STRUCT_DESC: 16-inch steel irrigation pipe through the levee, 4 feet below the crown. Cutoff wall around pipe at center of levee. Slant pump on the waterside (WS) slope, with 22-inch inlet pipe extending from channel. 16-inch pipe connects to 12-inch steel pipe at landside (LS) shoulder, extending to concrete standpipe discharge outlet at the toe. Cobble revetment on WS slope. (16-inch pipe installed and existing 16-inch pipe grouted work authorized under Permit No. 3314, 1960-C.M. Goethe) FS Date: 5/14/2013

View of waterward side--pipe, pump, control panels, and electrical conduit.

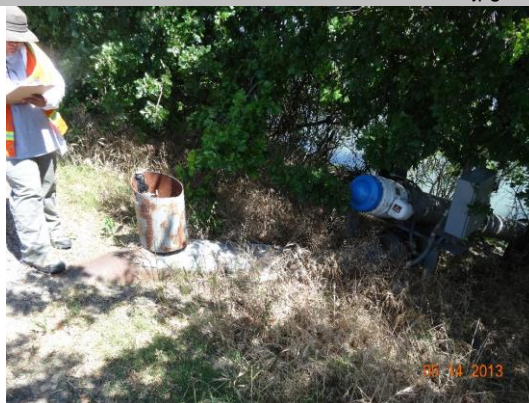
Photo 2 of 3 : UCIP_SP_2019_44403_60814.jpg

Siphon breaker encased in steel casing located on waterward side.

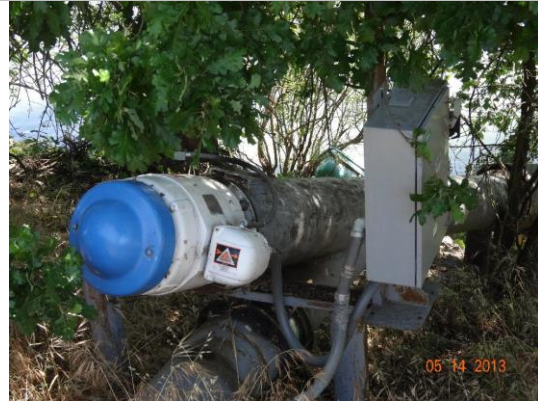
Photo 3 of 3 : UCIP_SP_2019_44403_60813.jpg

Comment Code						
Inspector Comment						
FS_ID:44403 DS_ID:21138 EP_NO: 3314 Repair Type: Non-Urgent Crossing Status: Found UCIP Comments: Dense vegetation limit's the ability to determine condition of landward slope for potential leaks associated with crossing. Recommend having owner clear slope to be able to properly inspect slopes for leaks. FIELD_STRUCT_DESC: 16-inch steel irrigation pipe through the levee, 4 feet below the crown. Cutoff wall around pipe at center of levee. Slant pump on the waterside (WS) slope, with 22-inch inlet pipe extending from channel. 16-inch pipe connects to 12-inch steel pipe at landside (LS) shoulder, extending to concrete standpipe discharge outlet at the toe. Cobble revetment on WS slope. (16-inch pipe installed and existing 16-inch pipe grouted work authorized under Permit No. 3314, 1960-C.M. Goethe) FS Date: 5/14/2013

Close up of slant pump and control panel on waterward side.

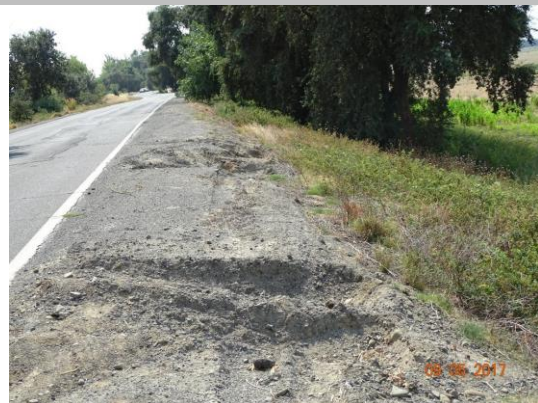
Photo 1 of 2 : SP_2019_RD0765_211_68_20190307_00041.jpg

LM Start	0.75	Rating **	M	Issue No.	68
LM End	0.75	Issue Type +	Ma	Location *	LS
Category	Earthen Levee			GPS Latitude/Longitude	
				Start	End
Item	Slope Stability			38.492705 °	38.492705 °
				-121.557193 °	-121.557193 °
DWR ID	DWR_RD0765_01_s_2017_68				
Comment Code					
S3 : Repair the levee slope damaged by vehicle traffic and prevent access where possible.					
Inspector Comment					
Repair slope damage likely caused by a truck.

Looking south on landside slope.

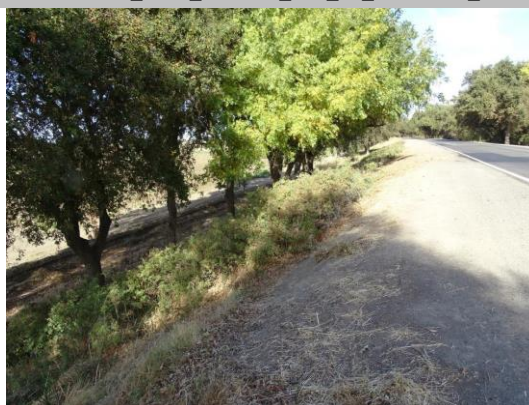
Photo 1 of 1 : SP_2019_RD0765_211_63_20190307_00039.jpg

LM Start	0.75	Rating **	M	Issue No.	63
LM End	0.79	Issue Type +	Ma	Location *	LS
Category	Earthen Levee			GPS Latitude/Longitude	
				Start	End
Item	Vegetation			38.492647 °	38.492145 °
				-121.557192 °	-121.556891 °
DWR ID	DWR_RD0765_01_s_2018_63				
Comment Code					
V2 : Remove the wild growth other than native grasses from the levee slopes.					
Inspector Comment

View of wild brush on levee slope. Fall 2018

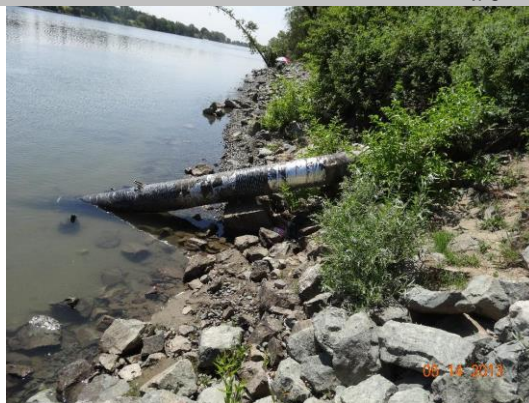
Photo 1 of 3 : UCIP_SP_2019_44404_60819.jpg

Comment Code						
Inspector Comment						
FS_ID:44404						
DS_ID:21139						
EP_NO: 653						
Repair Type: Non-Urgent						
Crossing Status: Found						
UCIP Comments: Dense vegetation on landward side limits visual inspection of potential leaks. Recommend clearing slope of vegetation.						
FIELD_STRUCT_DESC: 16-inch steel irrigation pipe through the levee, 14.3 feet below the crown. Pump on the landside (LS). Gate valve on the waterside (WS) slope. (16-inch pipe authorized under Permit No. 653, 1935-E. G. Elliott) [Additional Reference(s): DWR Levee Logs, 2005. USACE Sacramento O&M Manual Unit No. 114, April 1959, River Mile (RM) 50.29]]						
FS Date: 5/14/2013

Pipe section visible at waterward toe.

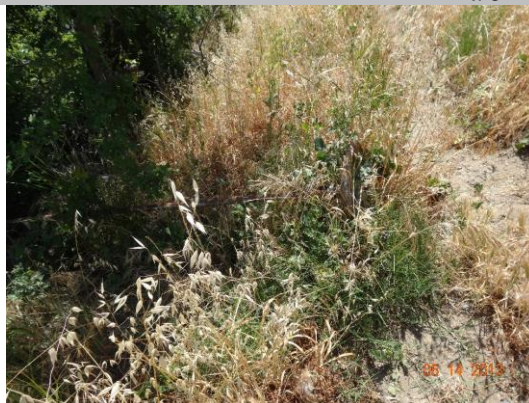
Photo 2 of 3 : UCIP_SP_2019_44404_60818.jpg

LM Start	0.95	Rating **	M	Issue No.	70 (cont)	
LM End	0.95	Issue Type +	En	Location *		
Category	Supplemental			GPS Latitude/Longitude		
				Start		End
Item	DWR UCIP Field Study			38.490192 °	38.490192 °	
				-121.555628 °	-121.555628 °	
DWR ID	21139					
Comment Code						
Inspector Comment						
FS_ID:44404 DS_ID:21139 EP_NO: 653 Repair Type: Non-Urgent Crossing Status: Found UCIP Comments: Dense vegetation on landward side limits visual inspection of potential leaks. Recommend clearing slope of vegetation. FIELD_STRUCT_DESC: 16-inch steel irrigation pipe through the levee, 14.3 feet below the crown. Pump on the landside (LS). Gate valve on the waterside (WS) slope. (16-inch pipe authorized under Permit No. 653, 1935-E. G. Elliott) [Additional Reference(s): DWR Levee Logs, 2005. USACE Sacramento O&M Manual Unit No. 114, April 1959, River Mile (RM) 50.29] FS Date: 5/14/2013

View of waterward side--dense vegetation limits inspection.

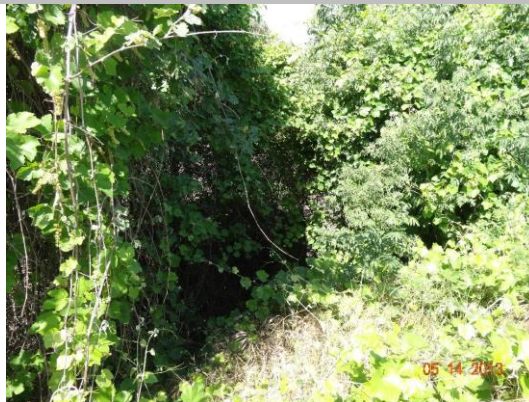
Photo 3 of 3 : UCIP_SP_2019_44404_60821.jpg

View of landward side--dense vegetation limits inspection.

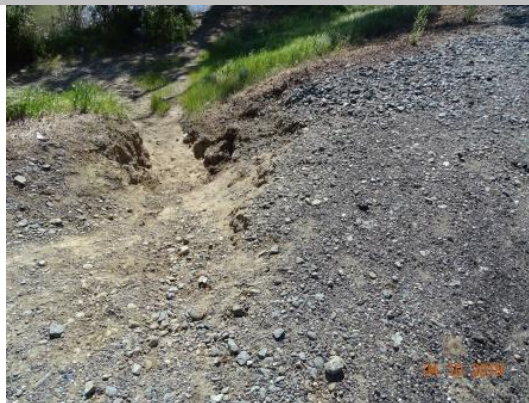
Photo 1 of 1 : SP_2019_RD0765_211_23_20190410_00059.jpg

LM Start	0.95	Rating **	M	Issue No.	23
LM End	0.95	Issue Type +	Ma	Location *	WS
Category	Earthen Levee			GPS Latitude/Longitude	
				Start	End
Item	Slope Stability			38.490067 °	38.490067 °
				-121.555530 °	-121.555530 °
DWR ID	DWR_RD0765_01_s_2019_23				
Comment Code					
S2 : Repair the levee slope damaged by foot traffic and prevent access where possible.					
Inspector Comment

View looking east at footpath that cuts into levee slope. Spring 2019

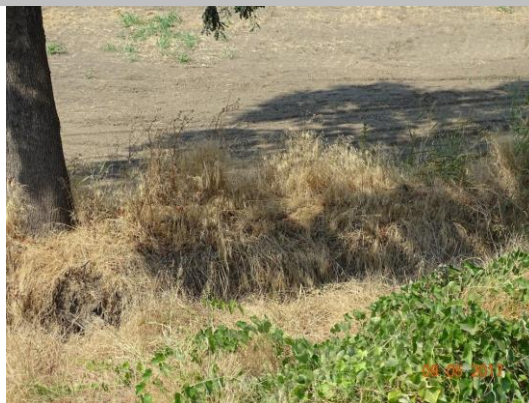
Photo 1 of 2 : SP_2019_RD0765_211_51_20190307_00028.jpg

LM Start	0.96	Rating **	M	Issue No.	51
LM End	1.02	Issue Type +	En	Location *	LS
Category	Earthen Levee			GPS Latitude/Longitude	
				Start	End
Item	Encroachments			38.489949 °	38.489230 °
				-121.555544 °	-121.555168 °
DWR ID	DWR_RD0765_01_s_2013_51				
Comment Code					
DT : Ditch					
Inspector Comment					
this ditch has been in place for several years. Most of the ditch appears to be outside the 15 foot right-of-way.

Looking northwest at the irrigation ditch on the landside toe.

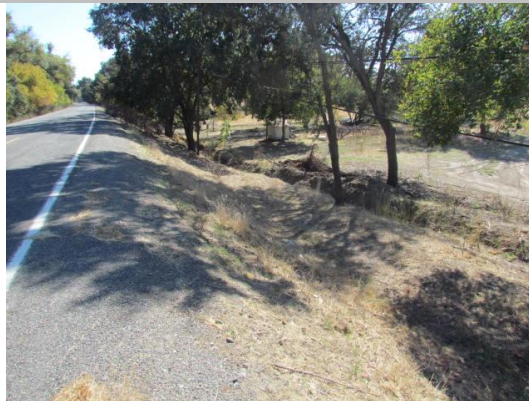
Photo 2 of 2 : SP_2019_RD0765_211_51_20190307_00029.jpg

Looking southwest at irrigation ditch on landward toe.

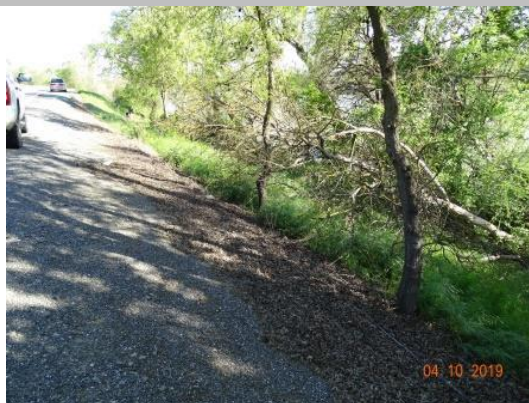
Photo 1 of 1 : SP_2019_RD0765_211_22_20190410_00058.jpg

View looking upstream at fallen tree on levee easement. Spring 2019

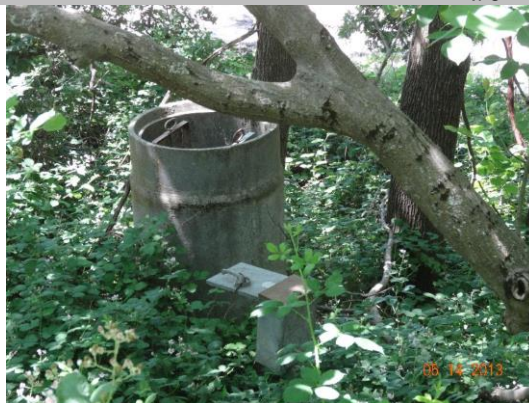
Photo 1 of 3 : UCIP_SP_2019_44407_73022.jpg

Comment Code					
Inspector Comment					
FS_ID:44407					
DS_ID:21140					
EP_NO: N/A					
Repair Type: Non-Urgent					
Crossing Status: Indicator Found					
UCIP Comments: Dense vegetation on waterward and landward slopes limit visual inspection of potential leaks along pipe alignment.					
Recommend having owner clear vegetation along slopes.					
FIELD_STRUCT_DESC: 6-inch steel pipe of unknown purpose through the levee, 18.8 feet below the crown. Concrete standpipe on the landise (LS) toe. Pump located on the waterside (WS) slope. [Additional					
Reference(s): USACE Sacramento O&M Manual Unit No. 114, April 1959, (river mile (RM) 50.15)]					
FS Date: 4/9/2015

Overview of landward side--concrete standpipe and control panel located at toe.

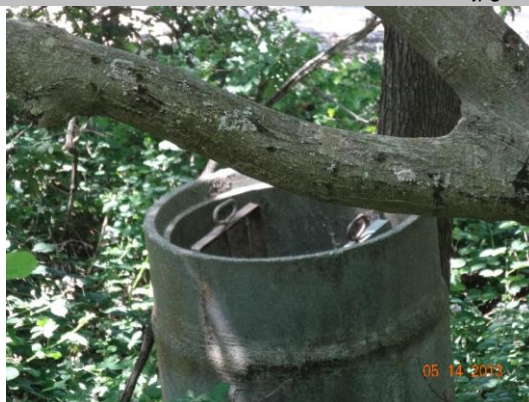
Photo 2 of 3 : UCIP_SP_2019_44407_73021.jpg

Concrete standpipe with 2 gates inside located on landward side.

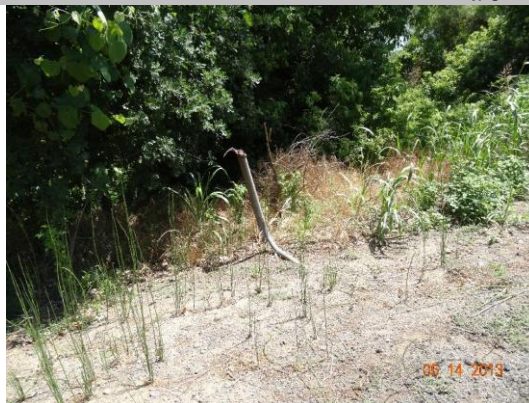
Photo 3 of 3 : UCIP_SP_2019_44407_73020.jpg

Comment Code						
Inspector Comment						
FS_ID:44407						
DS_ID:21140						
EP_NO: N/A						
Repair Type: Non-Urgent						
Crossing Status: Indicator Found						
UCIP Comments: Dense vegetation on waterward and landward slopes limit visual inspection of potential leaks along pipe alignment.						
Recommend having owner clear vegetation along slopes.						
FIELD_STRUCT_DESC: 6-inch steel pipe of unknown purpose through the levee, 18.8 feet below the crown. Concrete standpipe on the landise (LS) toe. Pump located on the waterside (WS) slope. [Additional						
Reference(s): USACE Sacramento O&M Manual Unit No. 114, April 1959, (river mile (RM) 50.15)]						
FS Date: 4/9/2015

Conduits disconnected and damaged on waterward side.

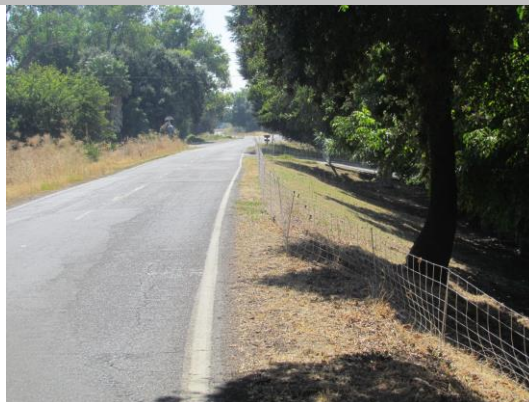
Photo 1 of 3 : SP_2019_RD0765_211_54_20190307_00033.jpg

LM Start	1.16	Rating **	M	Issue No.	54
LM End	1.26	Issue Type +	En	Location *	LS
Category	Earthen Levee			GPS Latitude/Longitude	
				Start	End
Item	Encroachments			38.487348 °	38.485984 °
				-121.554044 °	-121.553202 °
DWR ID	DWR_RD0765_01_s_2015_54				
Comment Code					
FE : Fence					
Inspector Comment					
Landowner installed a temporary fence on landside shoulder and slope.

Looking south at fencing for goats on landward slope. (Fall 2016)

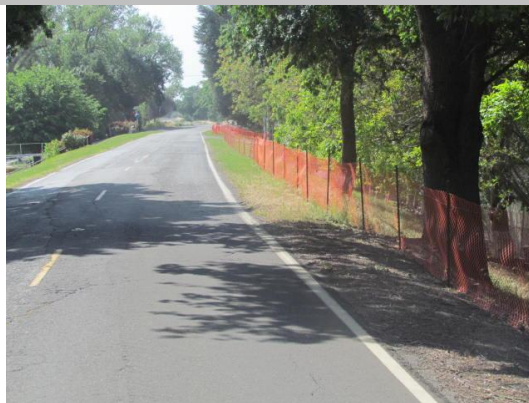
Photo 2 of 3 : SP_2019_RD0765_211_54_20190307_00034.jpg

Looking south at temporary fence on landward shoulder. (Spring 2016)

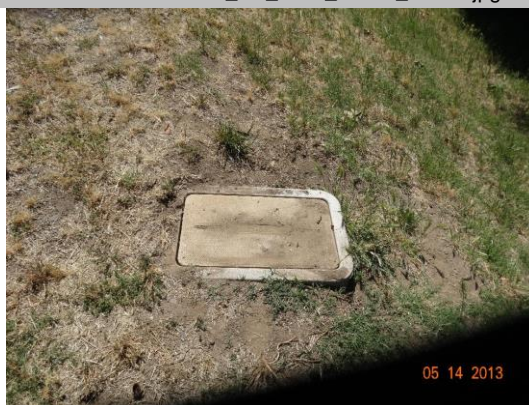
Photo 1 of 2 : UCIP_SP_2019_43203_71214.jpg

LM Start	1.20	Rating **	M	Issue No.	72
LM End	1.20	Issue Type +	En	Location *	
Category	Supplemental			GPS Latitude/Longitude	
				Start	End
Item	DWR UCIP Field Study			38.486830 °	38.486830 °
				-121.553698 °	-121.553698 °
DWR ID	24660				
Comment Code					
Inspector Comment					
FS_ID:43203 DS_ID:24660 EP_NO: N/A Repair Type: Non-Urgent Crossing Status: Indicator Found UCIP Comments: Unable to confirm details of crossing. Need to contact owner to determine additional details about crossing and permit issued. FIELD_STRUCT_DESC: PG&E utility service box located on the landside shoulder. FS Date: 5/14/2013

Utility box located on landward side.

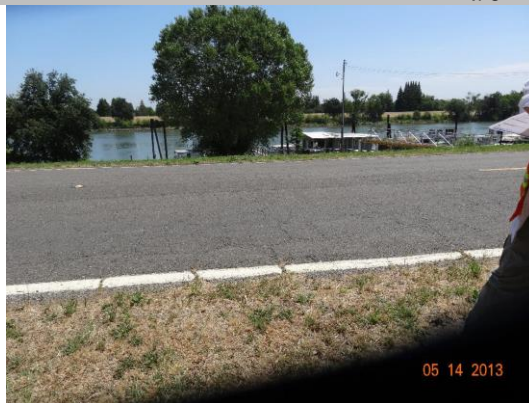
Photo 2 of 2 : UCIP_SP_2019_43203_71213.jpg

LM Start	1.20	Rating **	M	Issue No.	72 (cont)
LM End	1.20	Issue Type +	En	Location *	
Category	Supplemental			GPS Latitude/Longitude	
				Start	End
Item	DWR UCIP Field Study			38.486830 °	38.486830 °
				-121.553698 °	-121.553698 °
DWR ID	24660				
Comment Code					
Inspector Comment					
FS_ID:43203 DS_ID:24660 EP_NO: N/A Repair Type: Non-Urgent Crossing Status: Indicator Found UCIP Comments: Unable to confirm details of crossing. Need to contact owner to determine additional details about crossing and permit issued. FIELD_STRUCT_DESC: PG&E utility service box located on the landside shoulder. FS Date: 5/14/2013

View of levee crown and waterward side.

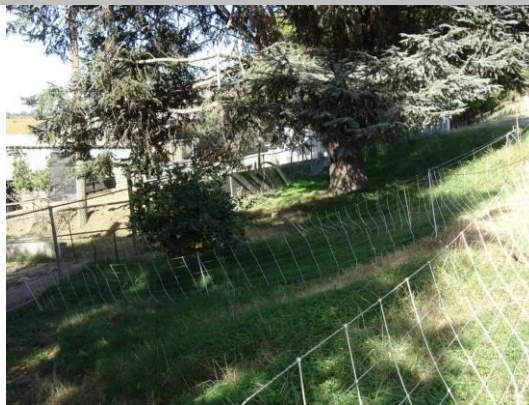
Photo 1 of 1 : SP_2019_RD0765_211_32_20190307_00019.jpg

LM Start	1.23	Rating **	M	Issue No.	32
LM End	1.23	Issue Type +	En	Location *	LS
Category	Earthen Levee			GPS Latitude/Longitude	
				Start	End
Item	Encroachments			38.486403 °	38.486403 °
				-121.553437 °	-121.553437 °
DWR ID	DWR_RD0765_01_f_2018_32				
Comment Code					
CR : Crops					
Inspector Comment					
Citrus tree is unpermitted within levee easement.

View of citrus tree within levee easement. Fall 2018

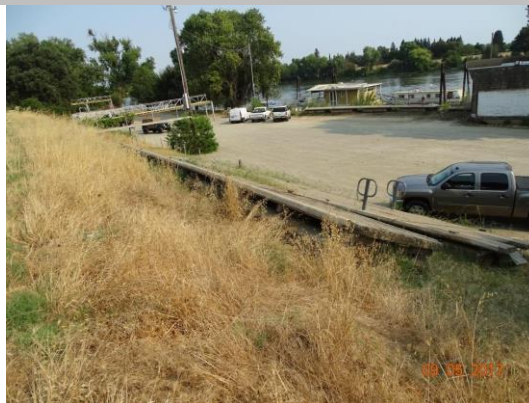
Photo 1 of 1 : SP_2019_RD0765_211_2_20190307_00002.jpg

Looking north at the waterside slope.

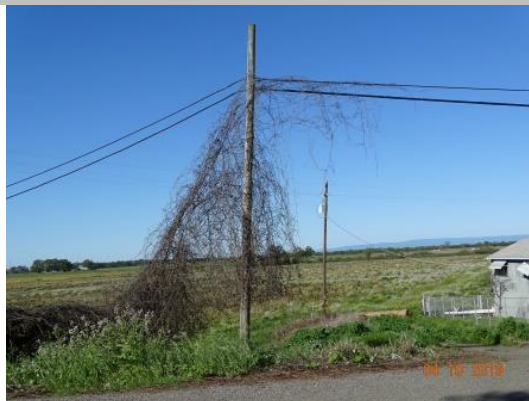
Photo 1 of 1 : SP_2019_RD0765_211_15_20190410_00057.jpg

LM Start	1.28	Rating **	U	Issue No.	15
LM End	1.32	Issue Type +	Ma	Location *	LS
Category	Earthen Levee			GPS Latitude/Longitude	
				Start	End
Item	Vegetation			38.485728 °	38.485210 °
				-121.553042 °	-121.552862 °
DWR ID	DWR_RD0765_01_s_2019_15				
Comment Code					
V2 : Remove the wild growth other than native grasses from the levee slopes.					
Inspector Comment					
Remove wild vines including the vines that have climbed up utility pole, which present a fire hazard.

View looking west at wild vines that have climbed up utility pole. Spring 2019

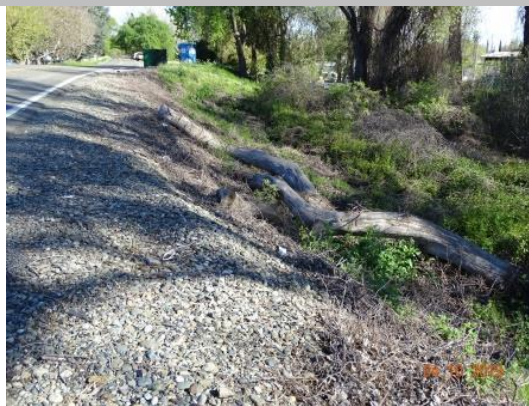
Photo 1 of 1 : SP_2019_RD0765_211_20_20190410_00056.jpg

View looking upstream at fallen tree on levee slope. Spring 2019

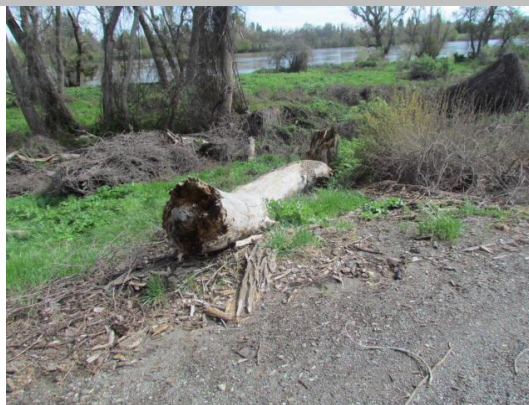
Photo 2 of 2 : SP_2019_RD0765_211_7_20190307_00009.jpg

Looking southeast at branch on waterward slope.

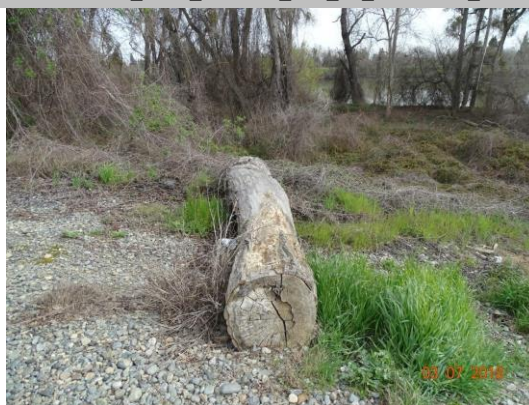
Photo 1 of 1 : SP_2019_RD0765_211_45_20190307_00024.jpg

Tree log on waterside slope is used to control vehicle access. Spring 2018

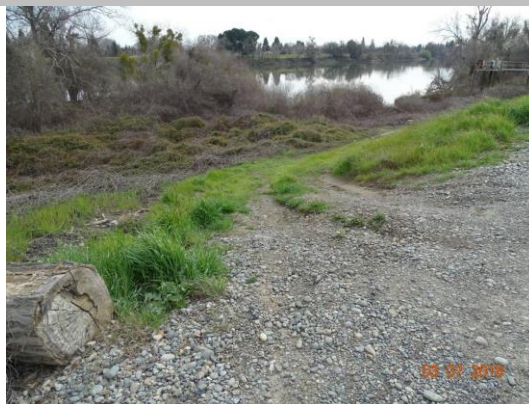
Photo 1 of 1 : SP_2019_RD0765_211_31_20190307_00018.jpg

LM Start	1.51	Rating **	M	Issue No.	31
LM End	1.51	Issue Type +	Ma	Location *	WS
Category	Earthen Levee			GPS Latitude/Longitude	
				Start	End
Item	Slope Stability			38.482788 °	38.482788 °
				-121.551048 °	-121.551048 °
DWR ID	DWR_RD0765_01_s_2018_31				
Comment Code					
S3 : Repair the levee slope damaged by vehicle traffic and prevent access where possible.					
Inspector Comment

View looking southeast at slope instability due to vehicle traffic. Spring 2018

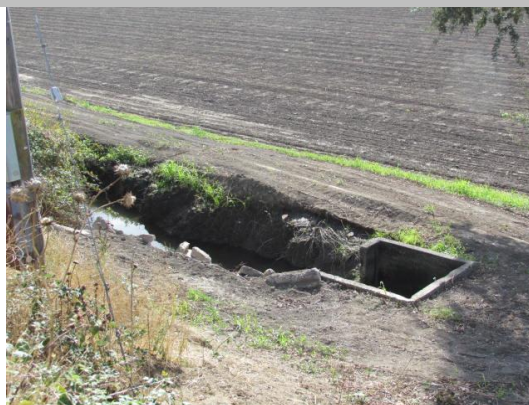
Photo 1 of 2 : SP_2019_RD0765_211_60_20190307_00037.jpg

Looking southwest at irrigation ditch at landward toe. (Fall 2014)

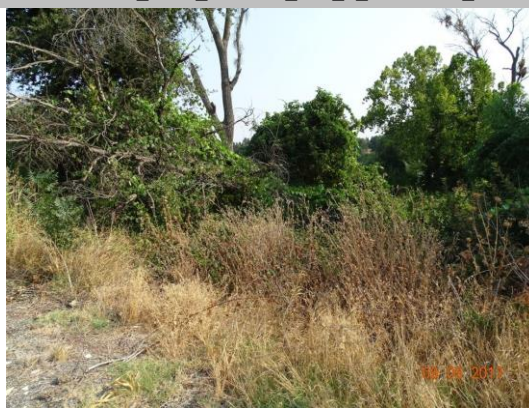
Photo 1 of 1 : SP_2019_RD0765_211_1_20190307_00001.jpg

View looking north at the fallen tree. Fall 2017

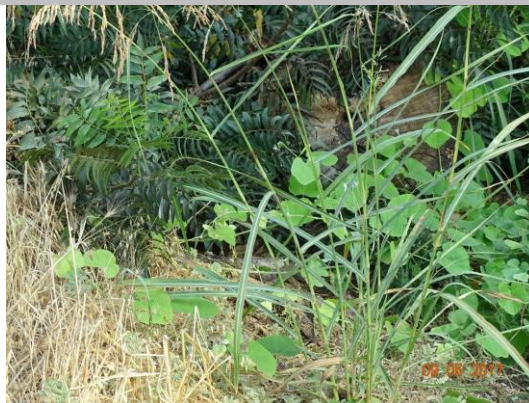
Photo 1 of 2 : SP_2019_RD0765_211_13_20190307_00014.jpg

Looking northwest at tree limb in vegetation on waterside slope. Fall 2017

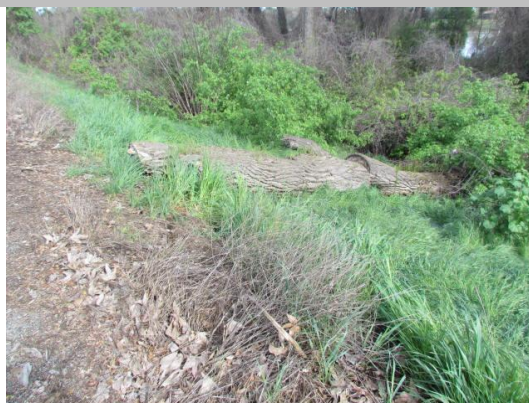
Photo 2 of 2 : SP_2019_RD0765_211_13_20190307_00015.jpg

Looking northwest at large tree limb on waterward slope.
